## HM56/56A

### Electrolytic Capacitor replacement

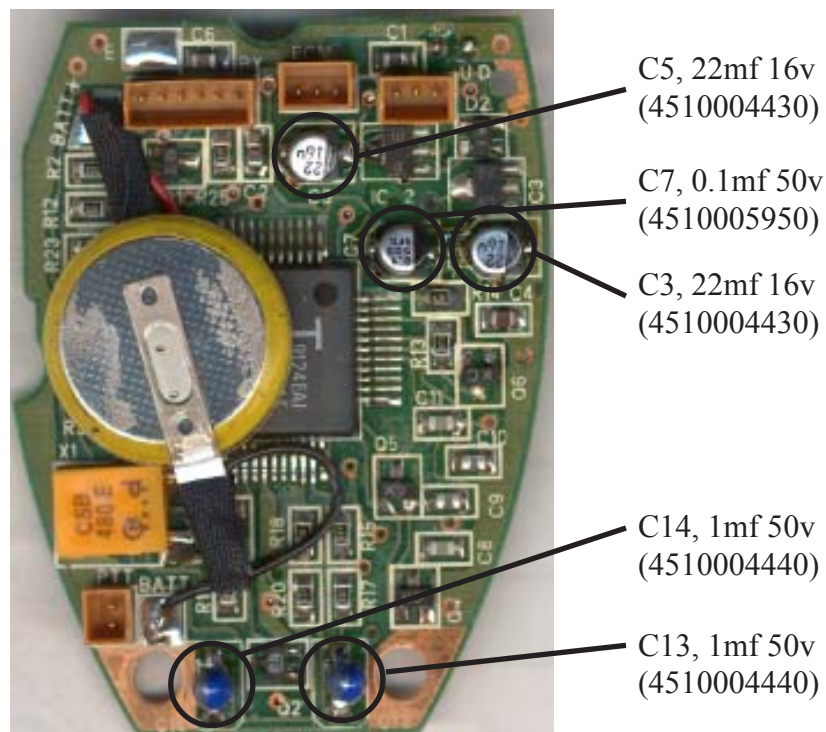
A common failure of the HM56/56A microphone, causing the radio to remain in TX mode when the mic is connected, is failure of the electrolytic capacitors on the microphone circuit board. Generally, replacing all 5 capacitors on the board repairs the problem and allows the microphone to work properly again. This repair is not a guarantee, simply a common failure point and reference for repair.

The 5 capacitors on the board are labeled as C3, C5, C7, C13 and C14. They can be ordered from the Icom parts department using the following part numbers:
